# Neal Inspections LLC

## Wind Mitigation Inspection Report

1836 Bough Ave  
Clearwater, FL 33760

# Uniform Mitigation Verification Inspection Form

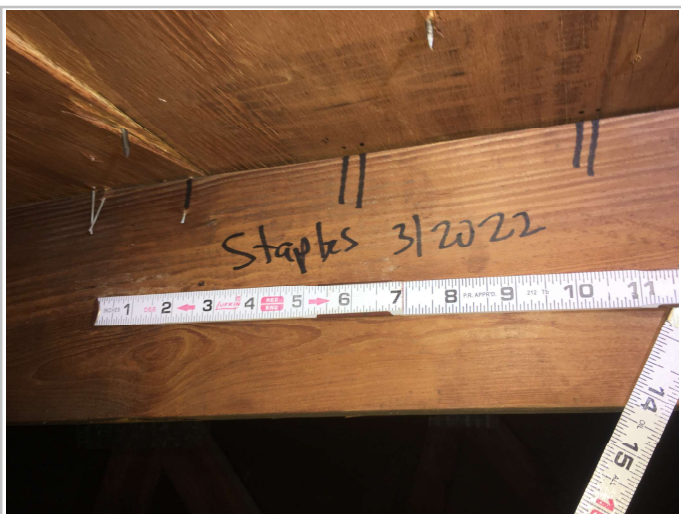
- ☒ A. Plywood/Oriented strand board (OSB) roof sheathing attached to the roof truss/rafter (spaced a maximum of 24" inches o.c.) by staples or 6d nails spaced at 6" along the edge and 12" in the field. -OR- Batten decking supporting wood shakes or wood shingles. -OR- Any system of screws, nails, adhesives, other deck fastening system or truss/rafter spacing that has an equivalent mean uplift less than that required for Options B or C below.  
☐ B. Plywood/OSB roof sheathing with a minimum thickness of 7/16" inch attached to the roof truss/rafter (spaced a maximum of 24" inches o.c.) by 8d common nails spaced a maximum of 12" inches in the field. -OR- Any system of screws, nails, adhesives, other deck fastening system or truss/rafter spacing that is shown to have an equivalent or greater resistance 8d nails spaced a maximum of 12 inches in the field or has a mean uplift resistance of at least 103 psf.

Stapled Roof Deck

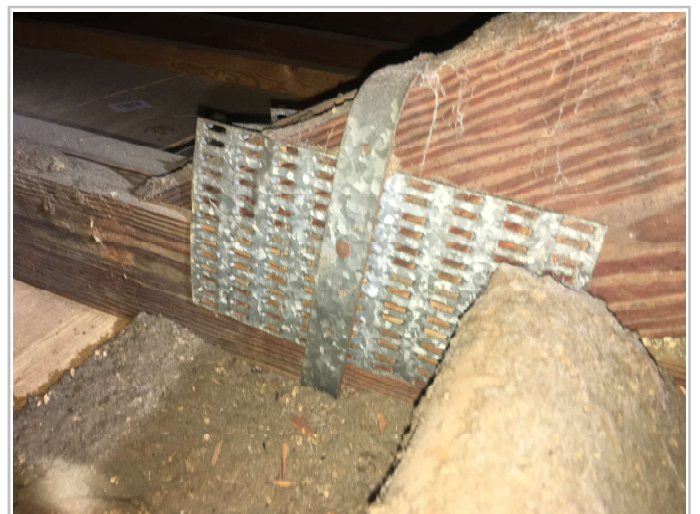
- ☒ A. Toe Nails
  - ☐ Truss/rafter anchored to top plate of wall using nails driven at an angle through the truss/rafter and attached to the top plate of the wall, or
  - ☒ Metal connectors that do not meet the minimal conditions or requirements of B, C, or D

Metal Connectors not Meeting Nail Requirements
