## Wind Mitigation Inspection Report

1846 Bough Ave  
Clearwater, FL 33760

# Uniform Mitigation Verification Inspection Form

| Inspection Date: 3/11/2022 | | |

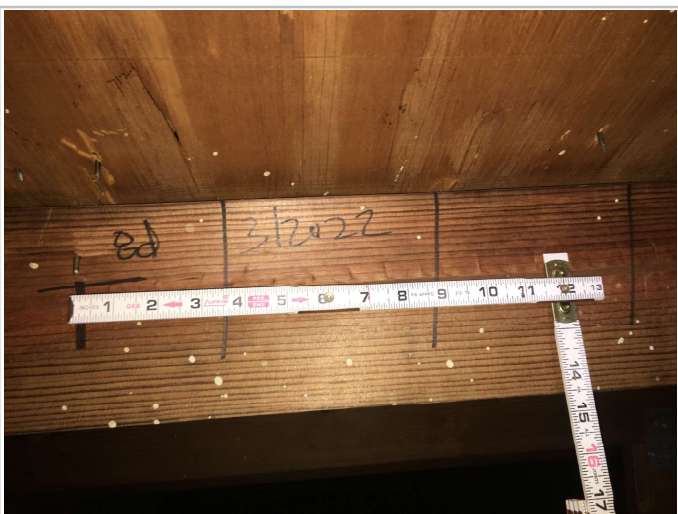
- ☒ C. Plywood/OSB roof sheathing with a minimum thickness of 7/16" inch attached to the roof truss/rafter (spaced a maximum of 24" inches o.c.) by 8d common nails spaced a maximum of 6" inches in the field. -OR- Dimensional lumber/Tongue & Groove decking with a minimum of 2 nails per board (or 1 nail per board if each board is equal to or less than 6 inches in width). -OR- Any system of screws, nails, adhesives, other deck fastening system or truss/rafter spacing that is shown to have an equivalent

8d Nails within 6"

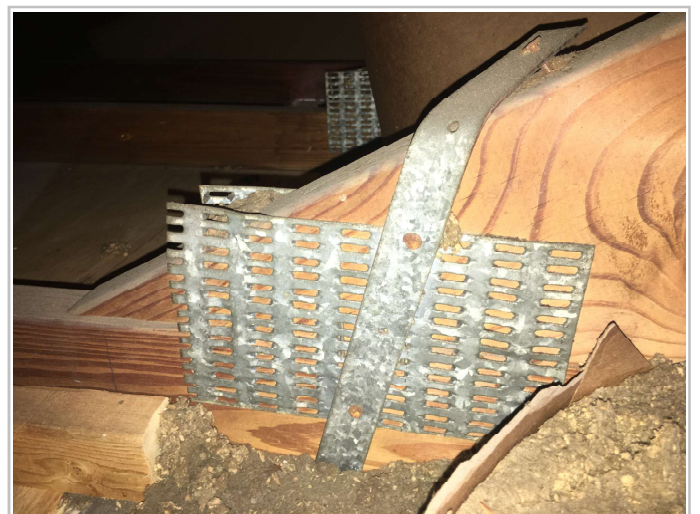
- ☒ A. Toe Nails
  - ☐ Truss/rafter anchored to top plate of wall using nails driven at an angle through the truss/rafter and attached to the top plate of the wall, or
  - ☒ Metal connectors that do not meet the minimal conditions or requirements of B, C, or D

Metal Connectors not Meeting Nail Requirements
