## Wind Mitigation Inspection Report

2934 Lichen Ln  
Clearwater, FL 33760

# Uniform Mitigation Verification Inspection Form

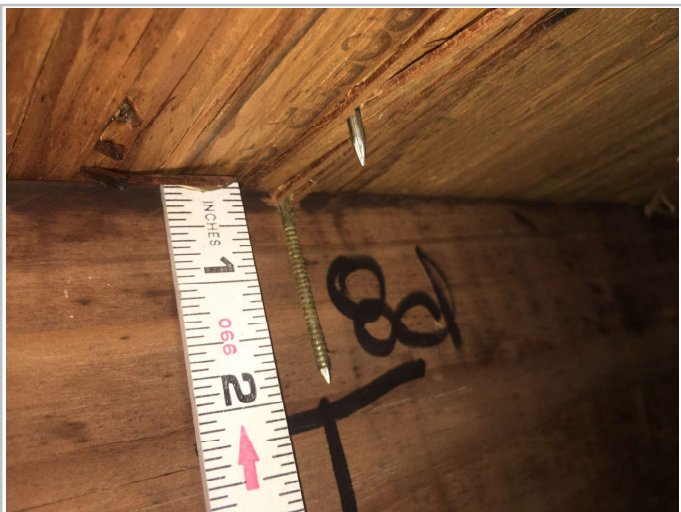
☒ C. Plywood/OSB roof sheathing with a minimum thickness of 7/16" inch attached to the roof truss/rafter (spaced a maximum of 24" inches o.c.) by 8d common nails spaced a maximum of 6" inches in the field. -OR- Dimensional lumber/Tongue & Groove decking with a minimum of 2 nails per board (or 1 nail per board if each board is equal to or less than 6 inches in width). -OR- Any system of screws, nails, adhesives, other deck fastening system or truss/rafter spacing that is shown to have an equivalent

8d Ringshank Renail

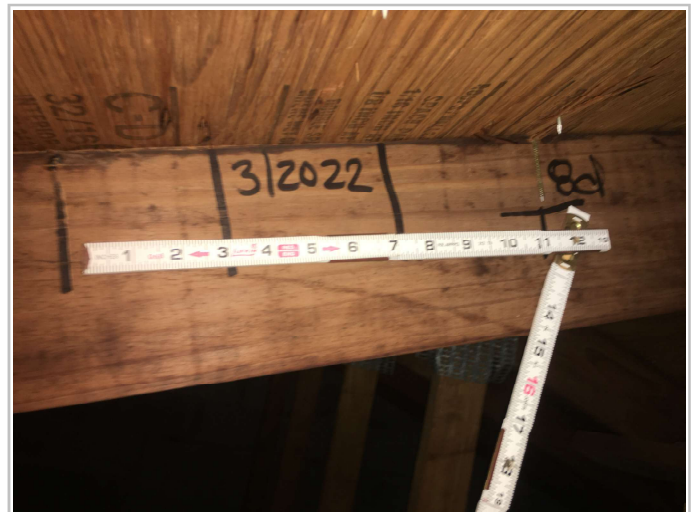
8d Nails within 6"

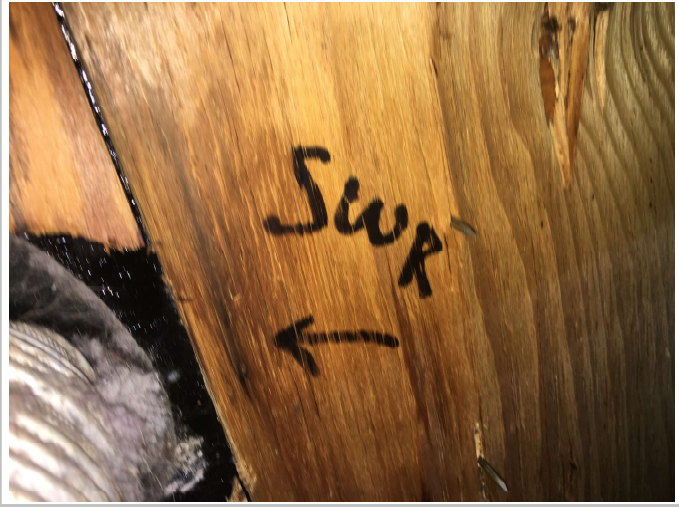
- ☒ A. SWR (also called Sealed Roof Deck) Self-adhering polymer modified-bitumen roofing underlayment applied directly to the sheathing or foam adhesive SWR barrier (not foamed-on insulation) applied as a supplemental means to protect the dwelling from water intrusion in the event of roof covering loss.
- ☐ B. No SWR.
- ☐ C. Unknown or undetermined.

SWR Confirmed

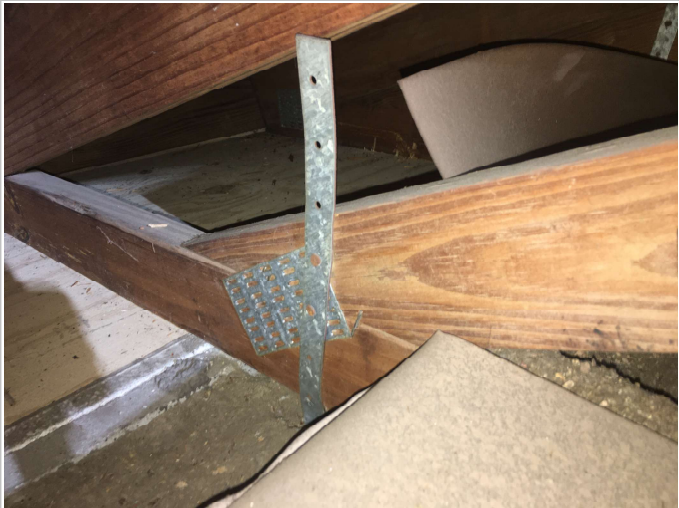
- ☒ A. Toe Nails
  - ☐ Truss/rafter anchored to top plate of wall using nails driven at an angle through the truss/rafter and attached to the top plate of the wall, or
  - ☒ Metal connectors that do not meet the minimal conditions or requirements of B, C, or D

Toe Nail - Straps not meeting nail requirements
