## Wind Mitigation Inspection Report

2936 Lichen Ln  
Clearwater, FL 33760

# Uniform Mitigation Verification Inspection Form

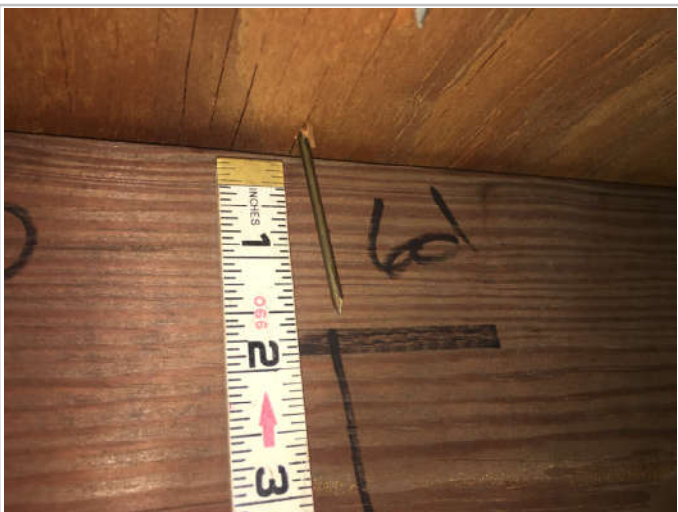
- Roof Deck Attachment:** What is the weakest form of roof deck attachment?
    - ☒ A. Plywood/Oriented strand board (OSB) roof sheathing attached to the roof truss/rafter (spaced a maximum of 24" inches o.c.) by staples or 6d nails spaced at 6" along the edge and 12" in the field. -OR- Batten decking supporting wood shakes or wood shingles. -OR- Any system of screws, nails, adhesives, other deck fastening system or truss/rafter spacing that has an equivalent mean uplift less than that required for Options B or C below.

6d Nails

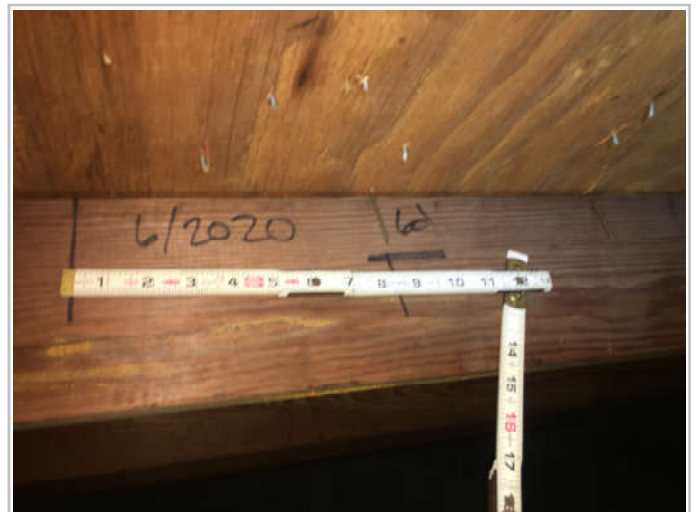
6d Nails within 12"

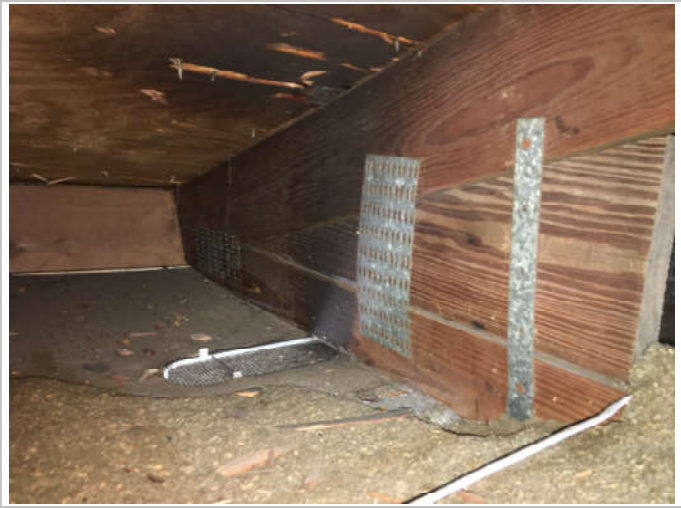
- ☒ A. Toe Nails
  - ☐ Truss/rafter anchored to top plate of wall using nails driven at an angle through the truss/rafter and attached to the top plate of the wall, or
  - ☒ Metal connectors that do not meet the minimal conditions or requirements of B, C, or D

Toe Nail - Not Meeting Nail Requirements
