## Wind Mitigation Inspection Report

2938 Lichen Ln  
Clearwater, FL 33760

# Uniform Mitigation Verification Inspection Form

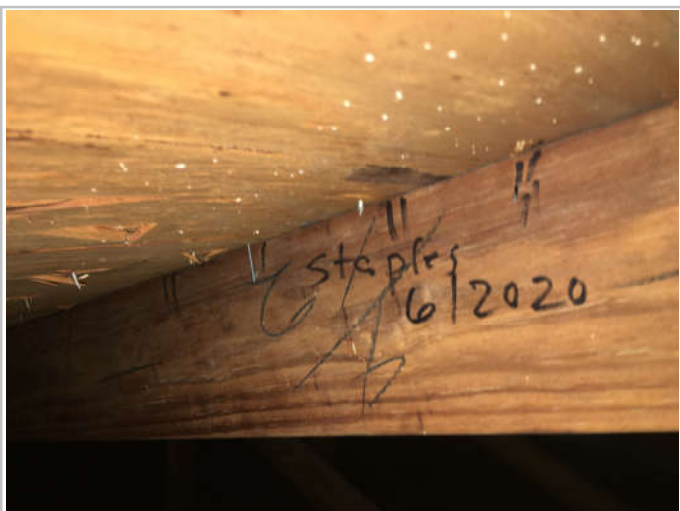
- ☒ A. Plywood/Oriented strand board (OSB) roof sheathing attached to the roof truss/rafter (spaced a maximum of 24" inches o.c.) by staples or 6d nails spaced at 6" along the edge and 12" in the field. -OR- Batten decking supporting wood shakes or wood shingles. -OR- Any system of screws, nails, adhesives, other deck fastening system or truss/rafter spacing that has an equivalent mean uplift less than that required for Options B or C below.  
☐ B. Plywood/OSB roof sheathing with a minimum thickness of 7/16" inch attached to the roof truss/rafter (spaced a maximum of 24" inches o.c.) by 8d common nails spaced a maximum of 12" inches in the field. -OR- Any system of screws, nails, adhesives, other deck fastening system or truss/rafter spacing that is shown to have an equivalent or greater resistance 8d nails spaced a maximum of 12 inches in the field or has a mean uplift resistance of at least 103 psf.

Stapled Roof Deck

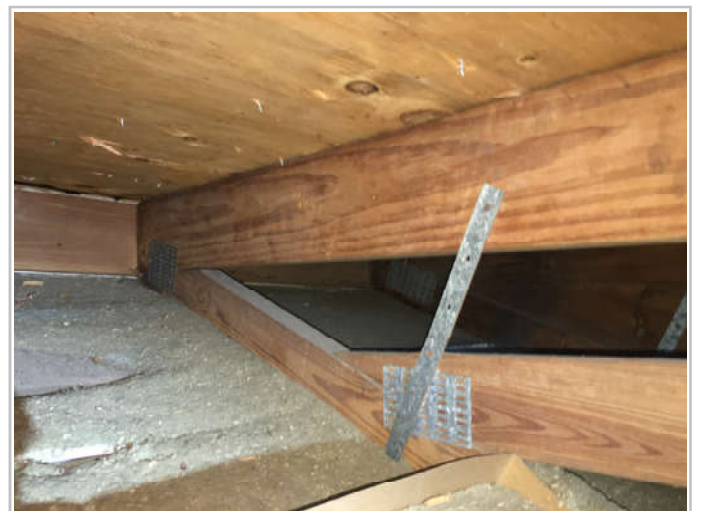
- ☒ A. Toe Nails
  - ☐ Truss/rafter anchored to top plate of wall using nails driven at an angle through the truss/rafter and attached to the top plate of the wall, or
  - ☒ Metal connectors that do not meet the minimal conditions or requirements of B, C, or D

Toe Nail - Not Meeting Nail Requirements
