## Wind Mitigation Inspection Report

2942 Lichen Ln  
Clearwater, FL 33760

# Uniform Mitigation Verification Inspection Form

| Inspection Date: 3/11/2022 | | |

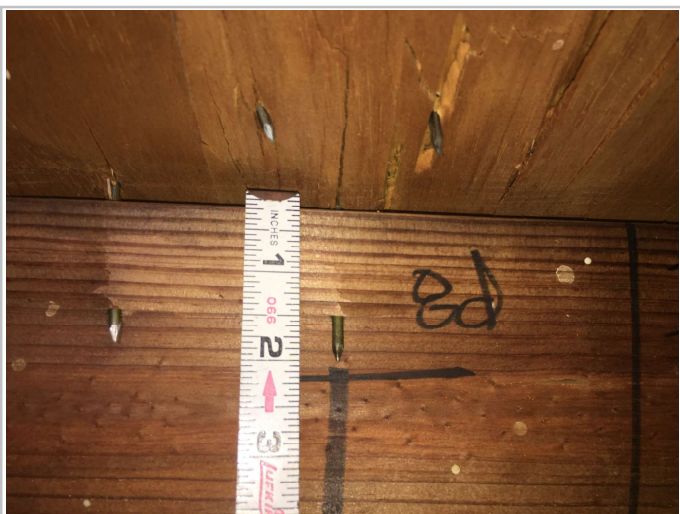
☒ C. Plywood/OSB roof sheathing with a minimum thickness of 7/16" inch attached to the roof truss/rafter (spaced a maximum of 24" inches o.c.) by 8d common nails spaced a maximum of 6" inches in the field. -OR- Dimensional lumber/Tongue & Groove decking with a minimum of 2 nails per board (or 1 nail per board if each board is equal to or less than 6 inches in width). -OR- Any system of screws, nails, adhesives, other deck fastening system or truss/rafter spacing that is shown to have an equivalent

8d Nails

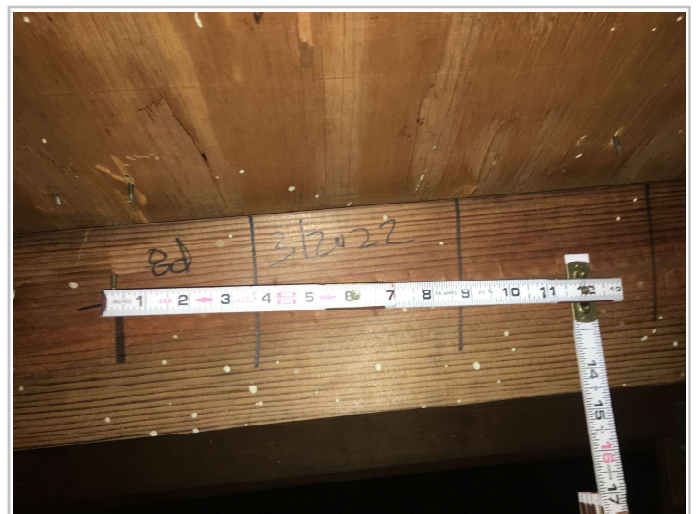
8d Nails within 6"

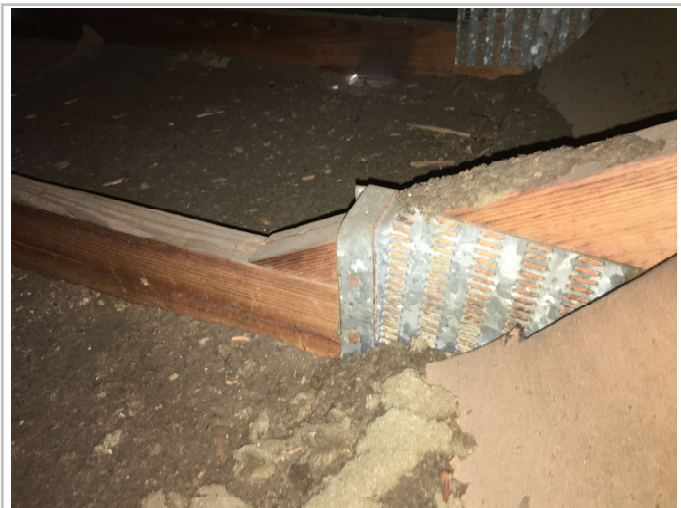
- ☒ A. Toe Nails
  - ☐ Truss/rafter anchored to top plate of wall using nails driven at an angle through the truss/rafter and attached to the top plate of the wall, or
  - ☒ Metal connectors that do not meet the minimal conditions or requirements of B, C, or D

Toe Nail - Straps not meeting nail requirements
