## Wind Mitigation Inspection Report

2944 Lichen Ln  
Clearwater, FL 33760

# Uniform Mitigation Verification Inspection Form

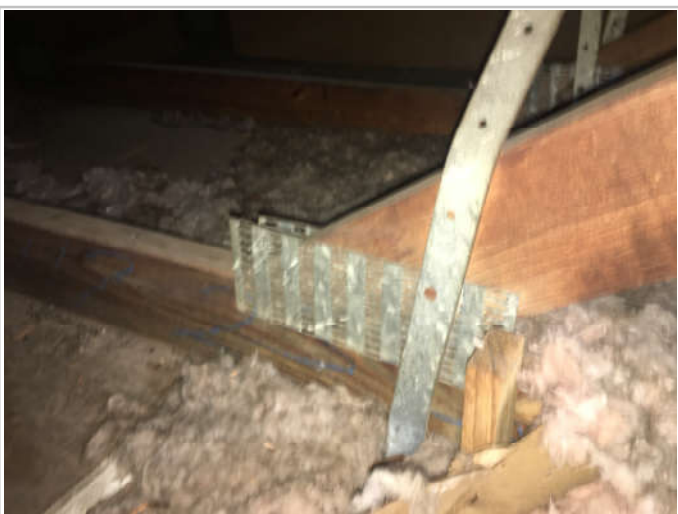
- ☒ A. Toe Nails
  - ☐ Truss/rafter anchored to top plate of wall using nails driven at an angle through the truss/rafter and attached to the top plate of the wall, or
  - ☒ Metal connectors that do not meet the minimal conditions or requirements of B, C, or D

Toe Nail - Not Meeting Nail Requirements

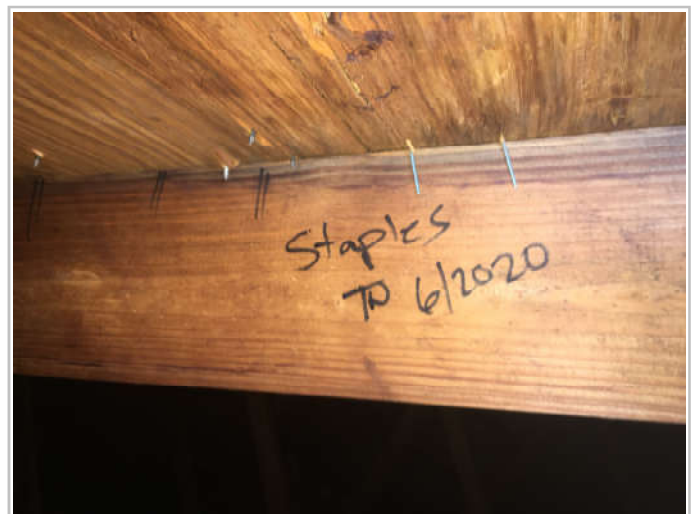
- Roof Deck Attachment:** What is the weakest form of roof deck attachment?
    - ☒ A. Plywood/Oriented strand board (OSB) roof sheathing attached to the roof truss/rafter (spaced a maximum of 24" inches o.c.) by staples or 6d nails spaced at 6" along the edge and 12" in the field. -OR- Batten decking supporting wood shakes or wood shingles. -OR- Any system of screws, nails, adhesives, other deck fastening system or truss/rafter spacing that has an equivalent mean uplift less than that required for Options B or C below.

Stapled Roof Deck
