# Neal Inspections LLC

## Wind Mitigation Inspection Report

1844 Bough Ave  
Clearwater, FL 33760

# Uniform Mitigation Verification Inspection Form

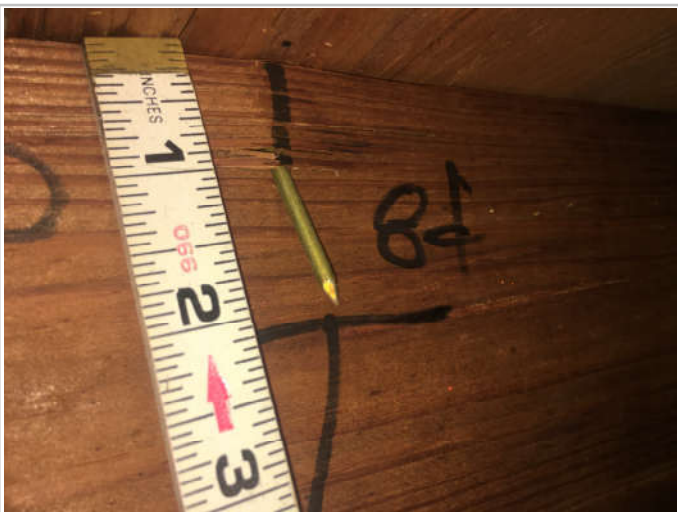
☒ C. Plywood/OSB roof sheathing with a minimum thickness of 7/16" inch attached to the roof truss/rafter (spaced a maximum of 24" inches o.c.) by 8d common nails spaced a maximum of 6" inches in the field. -OR- Dimensional lumber/Tongue & Groove decking with a minimum of 2 nails per board (or 1 nail per board if each board is equal to or less than 6 inches in width). -OR- Any system of screws, nails, adhesives, other deck fastening system or truss/rafter spacing that is shown to have an equivalent

8d Nails

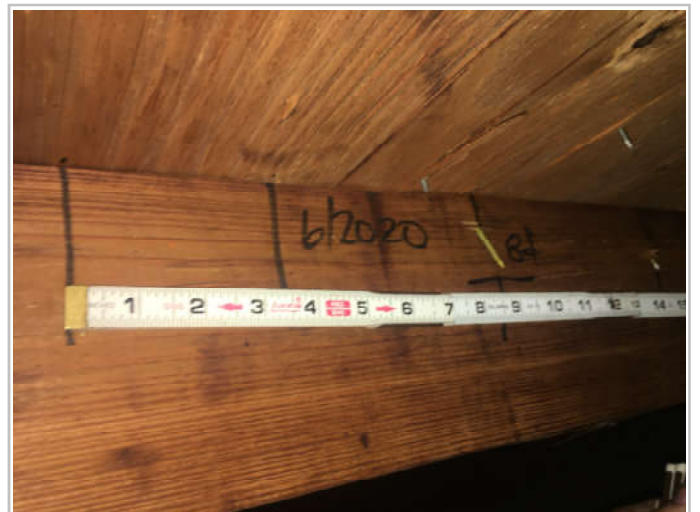
8d Nails within 6"

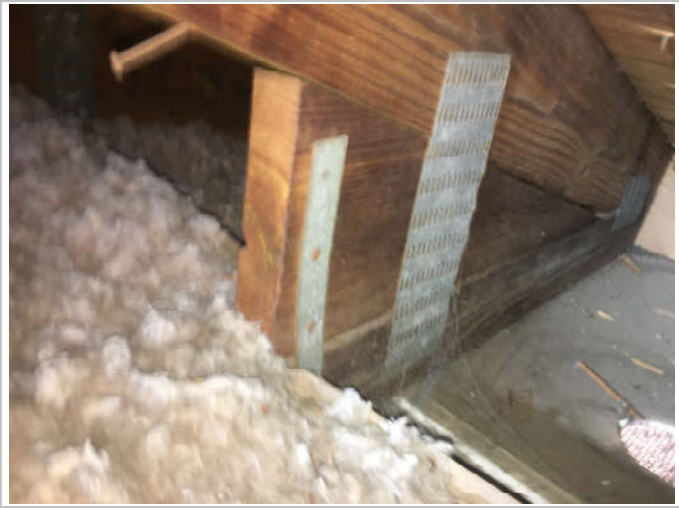
- ☒ A. Toe Nails
  - ☐ Truss/rafter anchored to top plate of wall using nails driven at an angle through the truss/rafter and attached to the top plate of the wall, or
  - ☒ Metal connectors that do not meet the minimal conditions or requirements of B, C, or D

Toe Nail - Not Meeting Nail Requirements

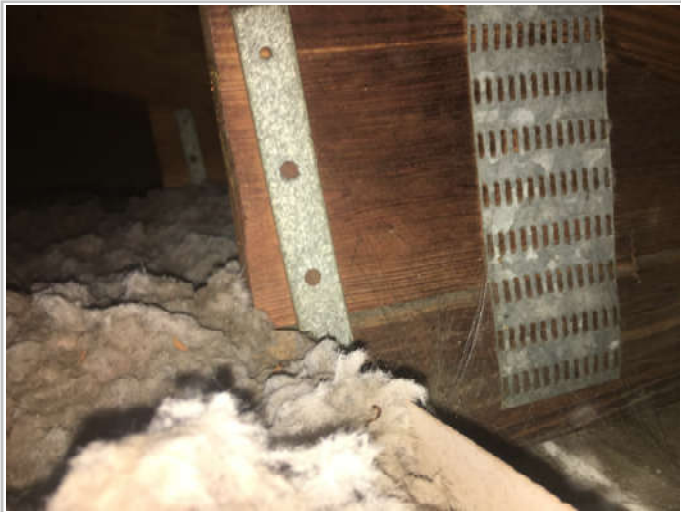
Toe Nail - Not Meeting Nail Requirements
